## Lower Paradise Creek Sub-Watershed Potential Restoration Sites

## Butz Run Sub-Watershed Potential Restoration Sites

## Cranberry Creek Sub-Watershed Potential Restoration Sites

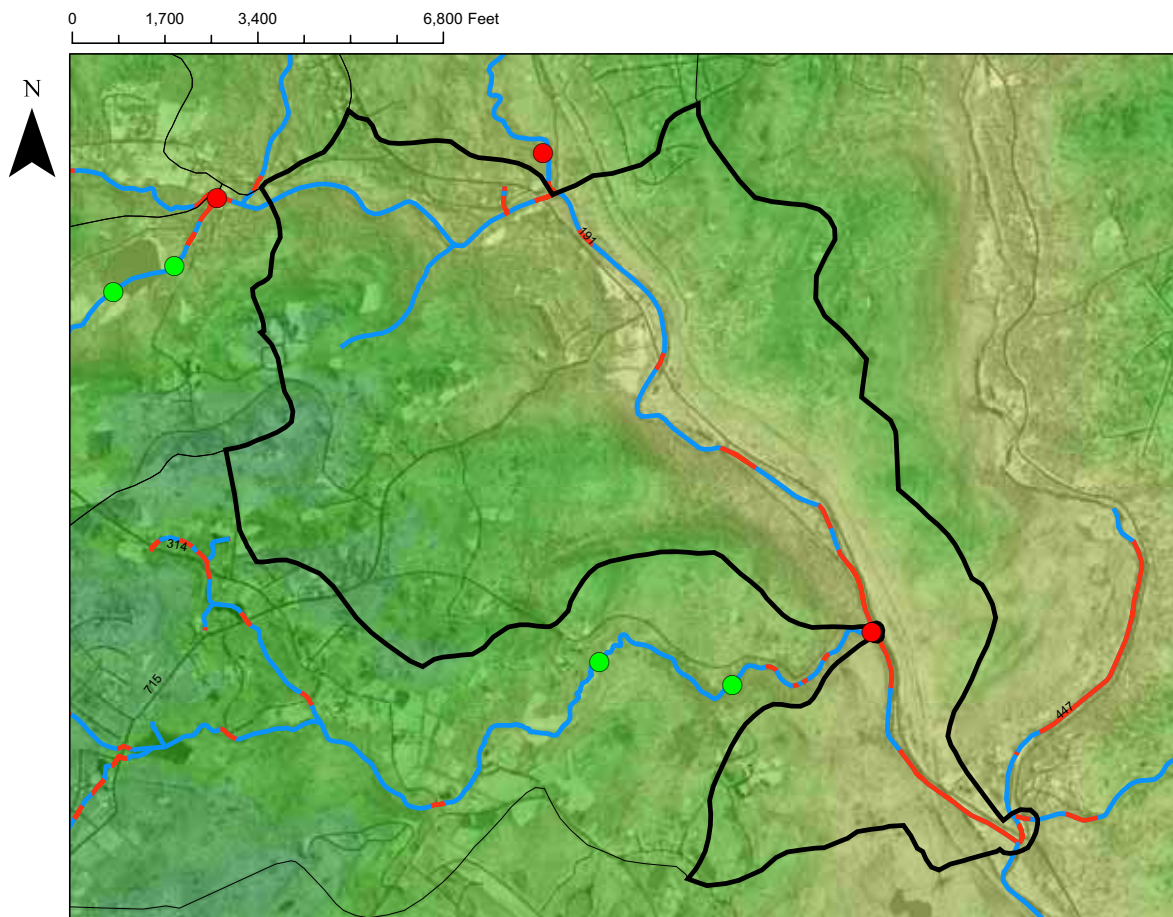
Figure 4 – Potential restoration sites in the Lower Paradise sub-watershed. Sites were identified by means of topographic map examination; stream proximity within 150 feet of roads, bridges and culverts; aerial photo examination and field verification.

1. Paradise Creek along Route 191 (4 segments): extensive channelization. Improve habitat within incised channel.

Install habitat improvement structures.

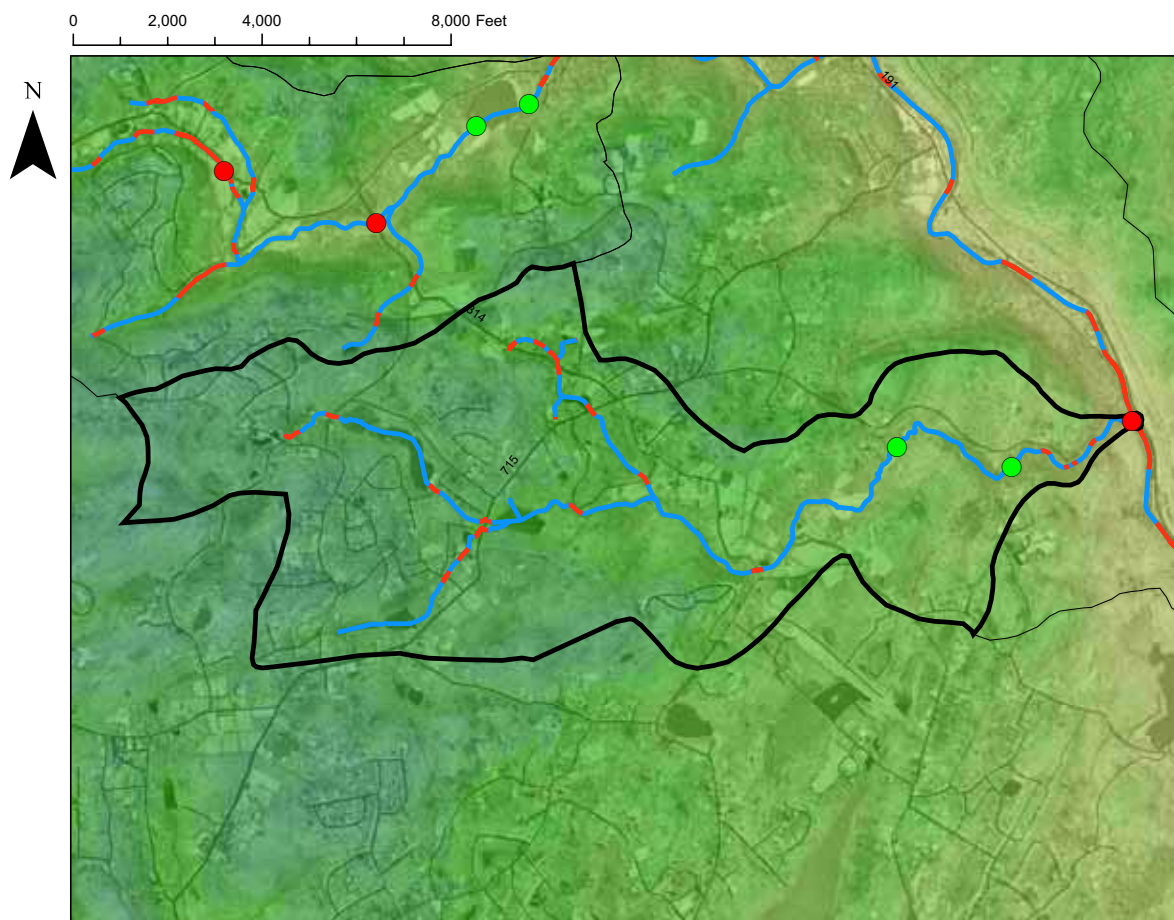
Figure 5 – Potential restoration sites in the Butz Run sub-watershed. Sites were identified by means of topographic map examination; stream proximity within 150 feet of roads, bridges and culverts; aerial photo examination and field verification.

1. Butz Run in Parcel 3571 just upstream of forest and abrupt gradient change entering hemlock valley.

Document reference reach morphology of E channel.

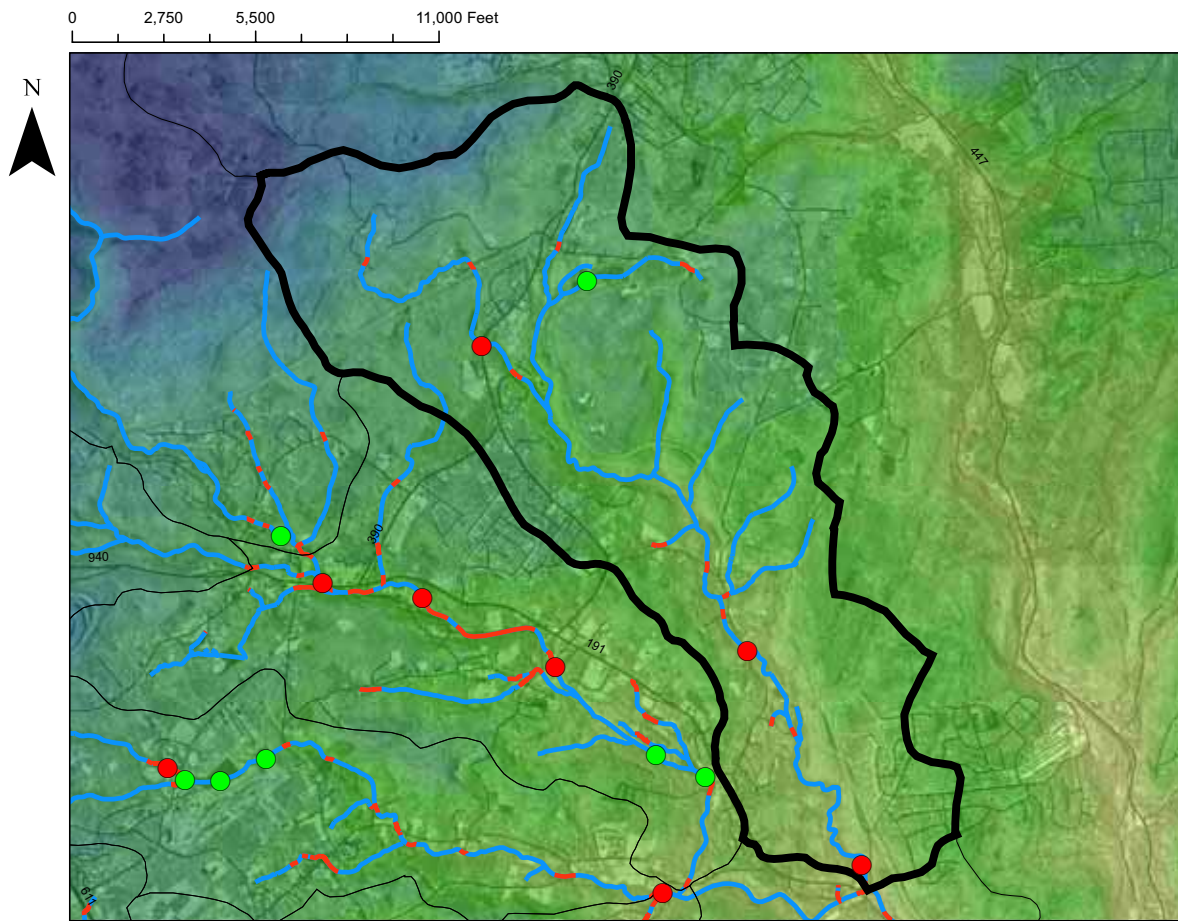
**Figure 6 – Potential restoration sites in the Cranberry Creek sub-watershed. Sites were identified by means of topographic map examination; stream proximity within 150 feet of roads, bridges and culverts; aerial photo examination and field verification.**

1. Cranberry Creek at Browns Hill Road crossing – multiple culverts, blockages, undersized.
2. Cranberry Ck at Cranberry Creek Road crossing – culvert effects.
3. Cranberry Ck UNT7 (R) at Route 191 crossing – culvert effects.

4. Cranberry Ck (L) through parcel 8534 peat mining operation, extreme channelization.

Road crossing is being renovated (proposed project as of January 2005)  
Crossing frequently floods, culvert undersized. Road runoff is potential problem. Possible project.  
Road runoff should be captured and treated.

See 8534 Aerial Photo. Extensive disturbance of stream channel, mitigation necessary once mining operation is completed.

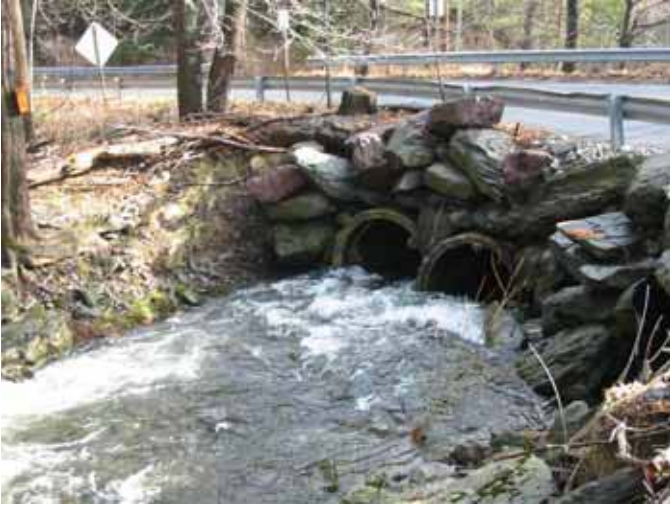
**Figure 7 - Cranberry Creek at Browns Hill Road: culvert is undersized, threatens road. Culvert should be replaced and sized sufficiently to provide additional cross sectional area and improve fish passage.**

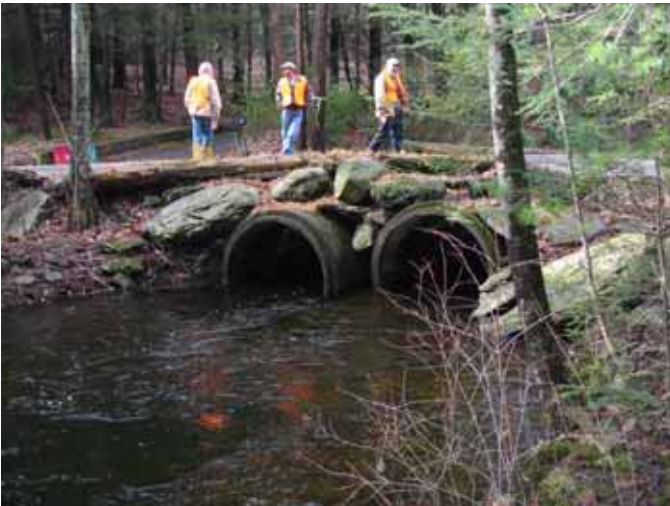
**Figure 8 - Cranberry Creek at Cranberry Creek Road crossing. Culvert undersized, road frequently floods. Stream receives a large amount of road runoff. Non-point source pollution management recommended here.**

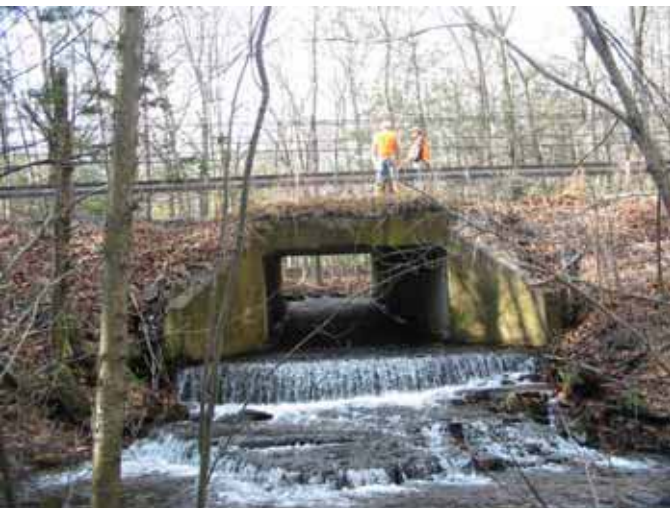
**Figure 9 - Cranberry Creek at Route 191 crossing. This location receives a large quantity of road runoff, which should be managed to reduce introduction of pollutants to stream.**

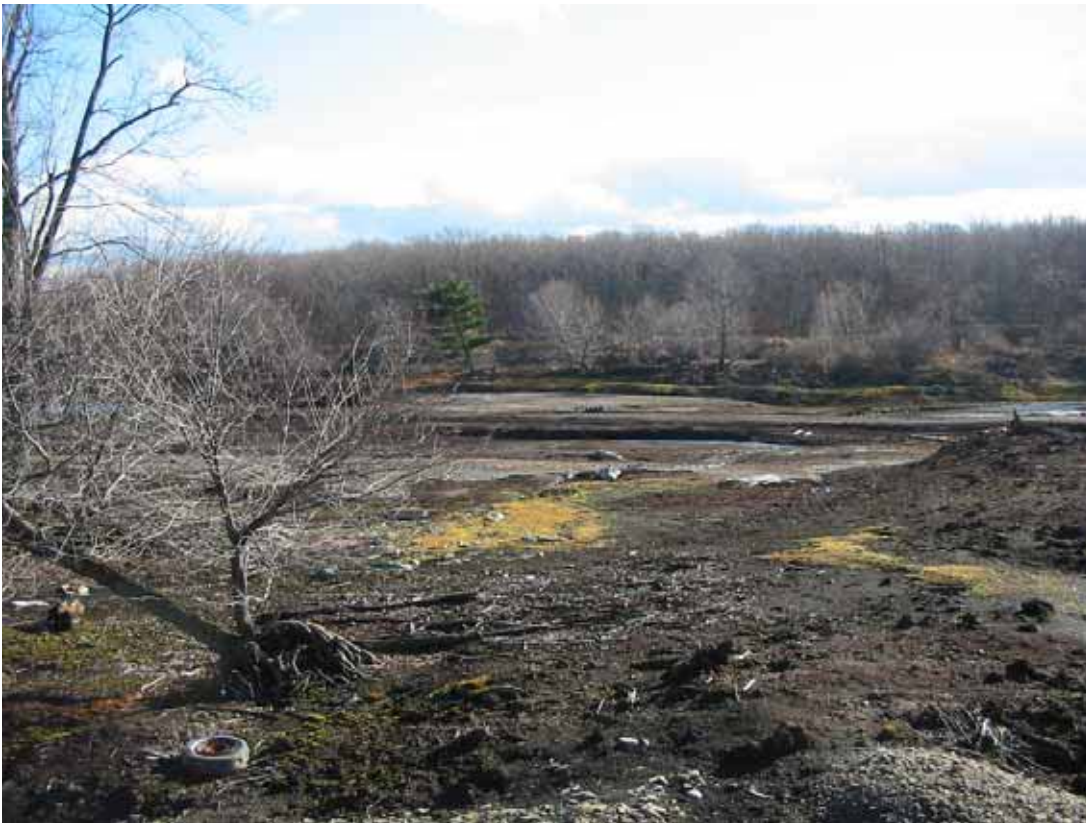
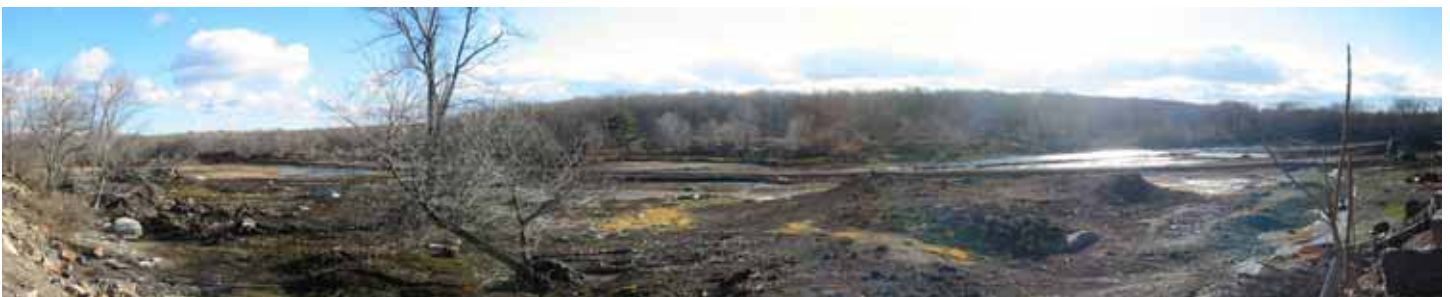
**Figure 10 (left) and Figure 11 (below): headwaters of Cranberry Creek watershed at active peat mining operation. Upon conclusion of peat mining operations, this site will require extensive restoration. Little is presently done to manage water quality impacts at this site.**
